Limited Visual Dam Safety Inspections

OA00137

Oahu Reservoir No. 155

May 2006

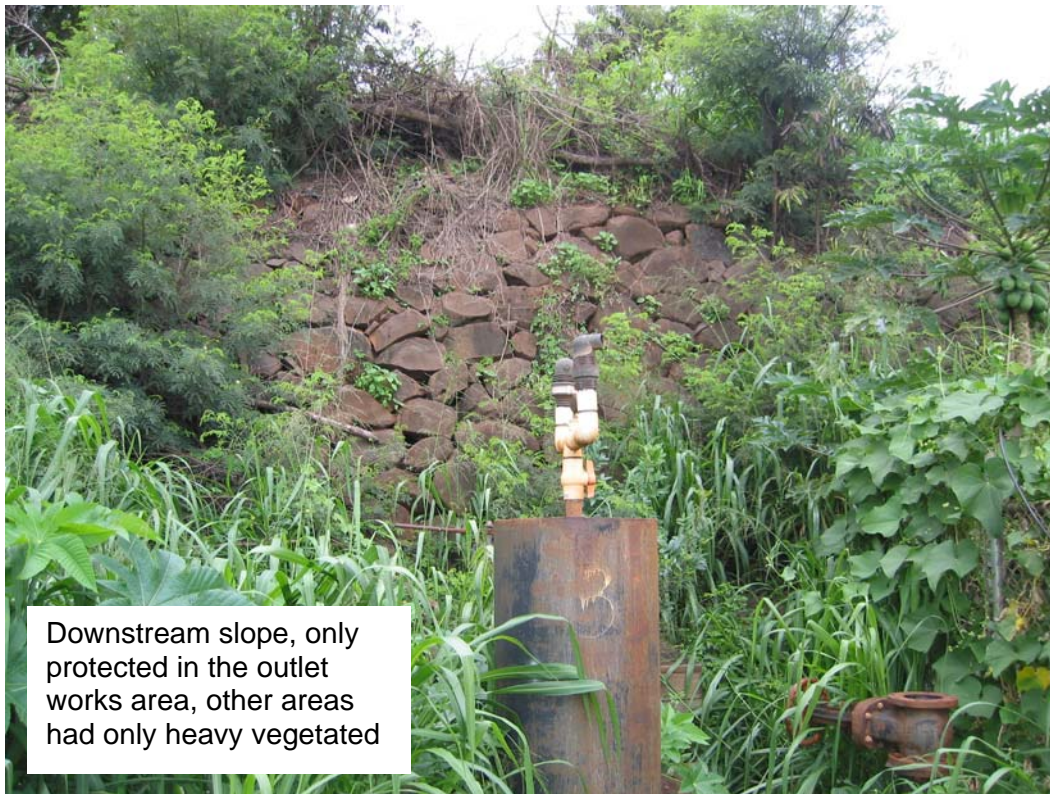
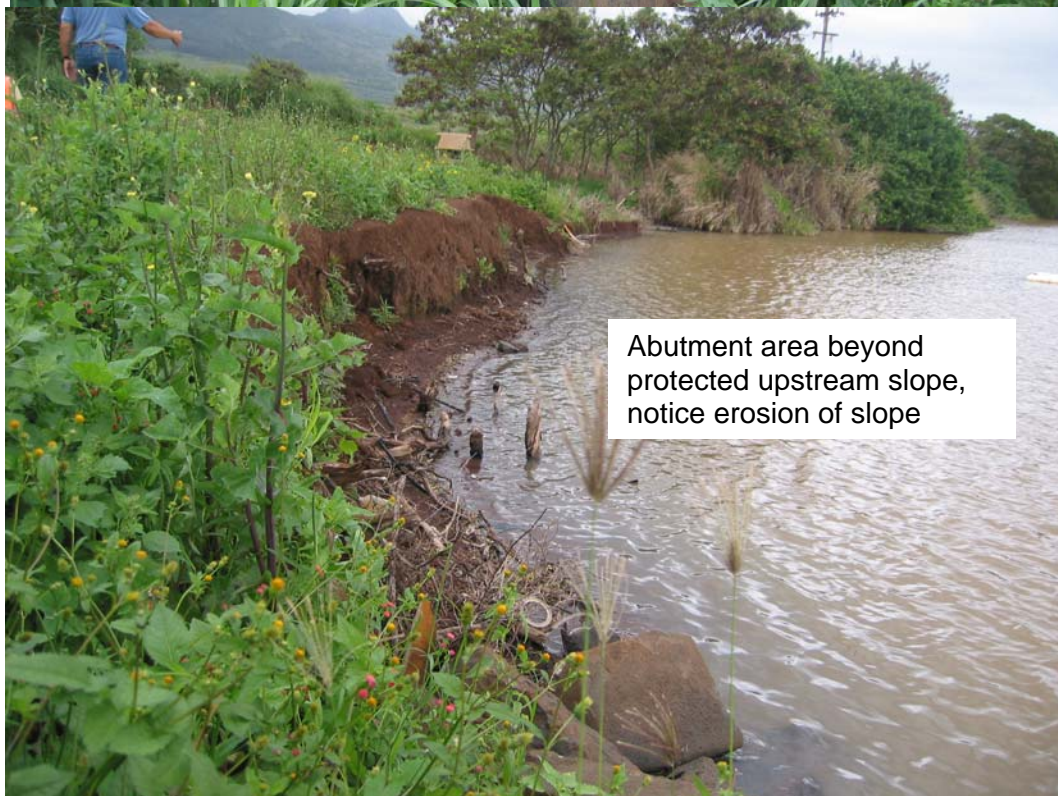
Looking at the upstream slope, notice heavy vegetation

No immediate threat observed on the date of inspection to the dam structure. The erosion by the spillway creating a vertical slope should be corrected eventually. Heavy vegetation should be removed and a decision to re-inspect be made at that time.
